Targhee Pass Project - Design Issues for Alternatives

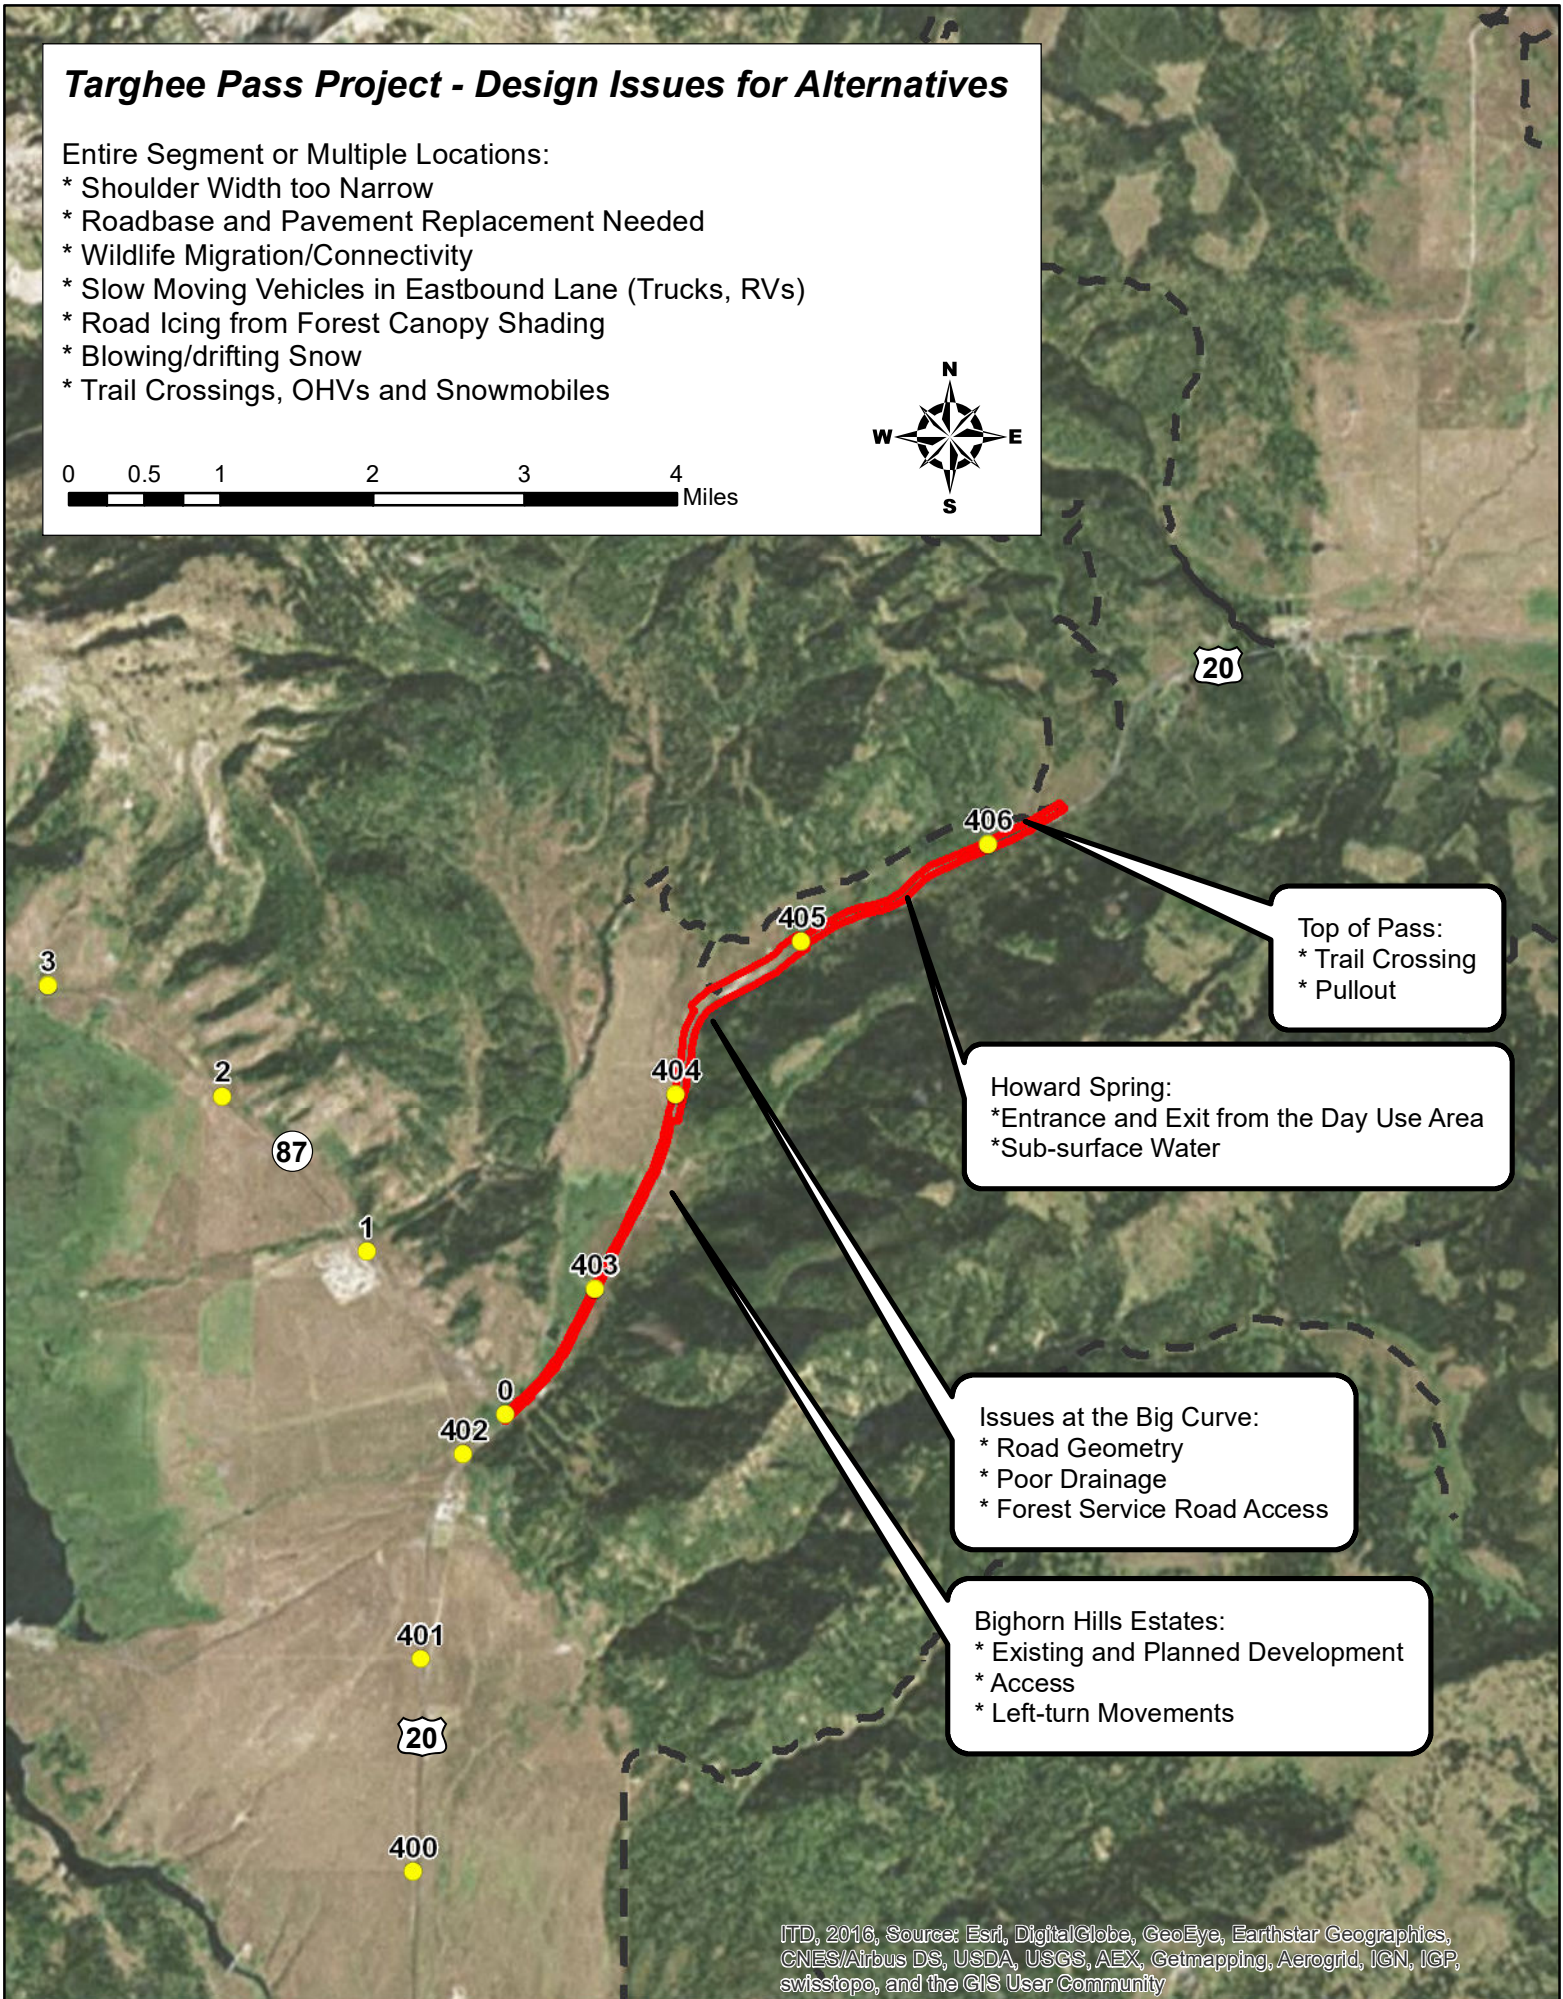
Entire Segment or Multiple Locations:

- * Shoulder Width too Narrow
- * Roadbase and Pavement Replacement Needed
- * Wildlife Migration/Connectivity
- * Slow Moving Vehicles in Eastbound Lane (Trucks, RVs)
- * Road Icing from Forest Canopy Shading
- * Blowing/drifting Snow
- * Trail Crossings, OHVs and Snowmobiles

Top of Pass:
* Trail Crossing
* Pullout

Howard Spring:
* Entrance and Exit from the Day Use Area
* Sub-surface Water

Issues at the Big Curve:
* Road Geometry
* Poor Drainage
* Forest Service Road Access

Bighorn Hills Estates:
* Existing and Planned Development
* Access
* Left-turn Movements
